The Northridge Earthquake - 30 Years Later *A Catalyst for Engineering Resilient Communities*

2024 Webinar Series

Episode 1: The January 17, 1994 Northridge Earthquake – Science and Engineering Aspects

The Northridge Earthquake
30 Years Later, A Catalyst for Engineering Resilient Communities

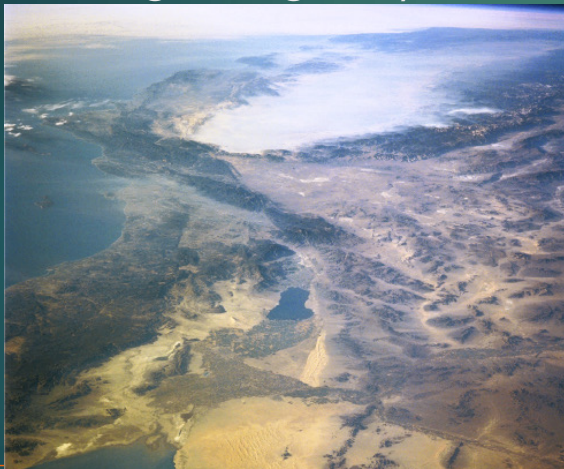
The San Andreas Transform ... a wrinkle - The Big Bend (compression & thrust faulting along SAF)

NASA Space Shuttle Photograph STS103-701-39

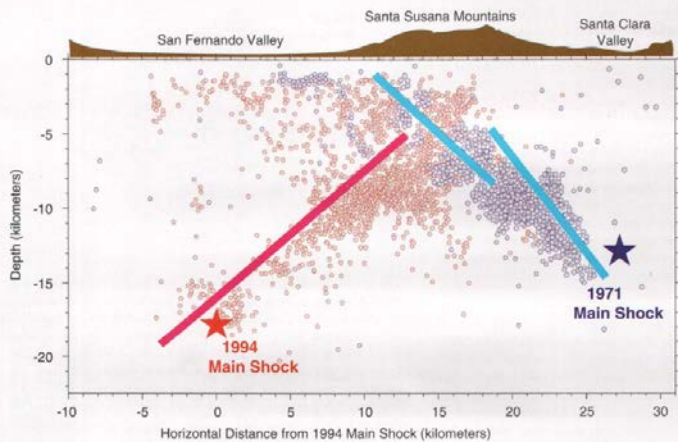
1971 and 1994 aftershocks & fault planes

Models of the fault planes of the 1994 Northridge (magenta) and 1971 San Fernando earthquakes (blue) suggest that movement on the buried thrust fault responsible for the Northridge earthquake terminated about 5 kilometers beneath the surface. This movement may have terminated against one of the faults that moved in 1971. Stars show positions of the hypocenters of the two shocks, and the arrays of red and blue dots indicate locations of aftershocks. Compare this illustration with the perspective view on page 13.

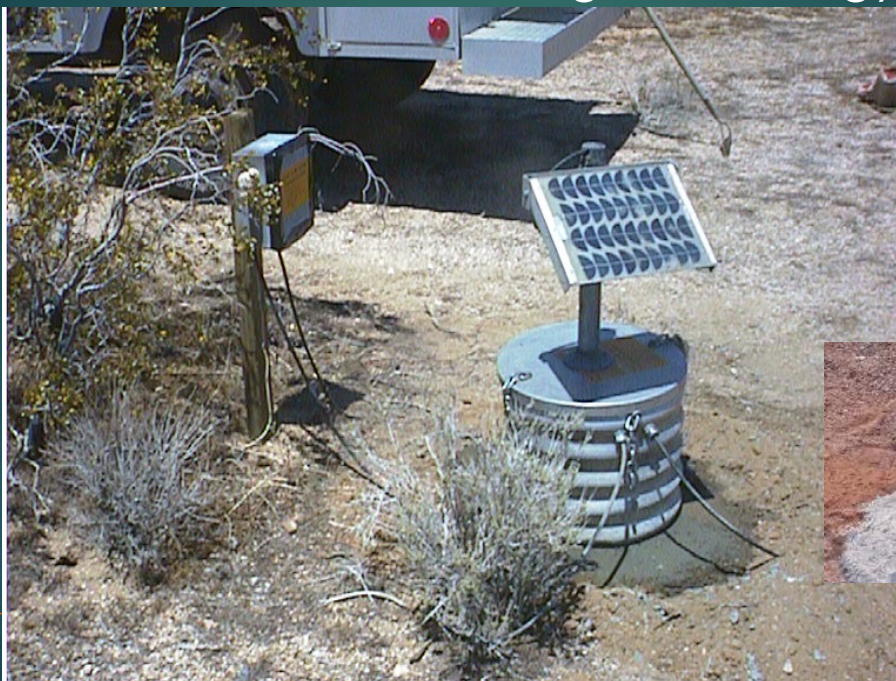
Network of real-time sensors in 1994

Analog technology

L4C
seismometer

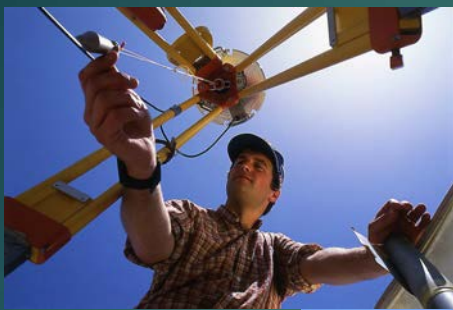
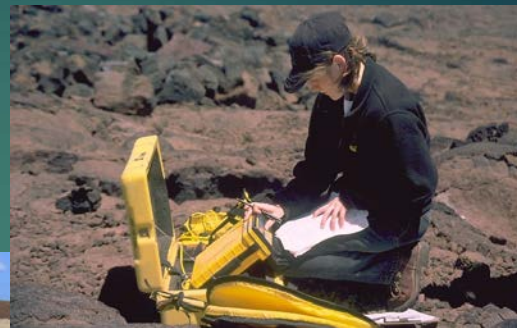
Survey-mode GPS in the era of NR'94

To obtain displacements for a dozen sites took five days

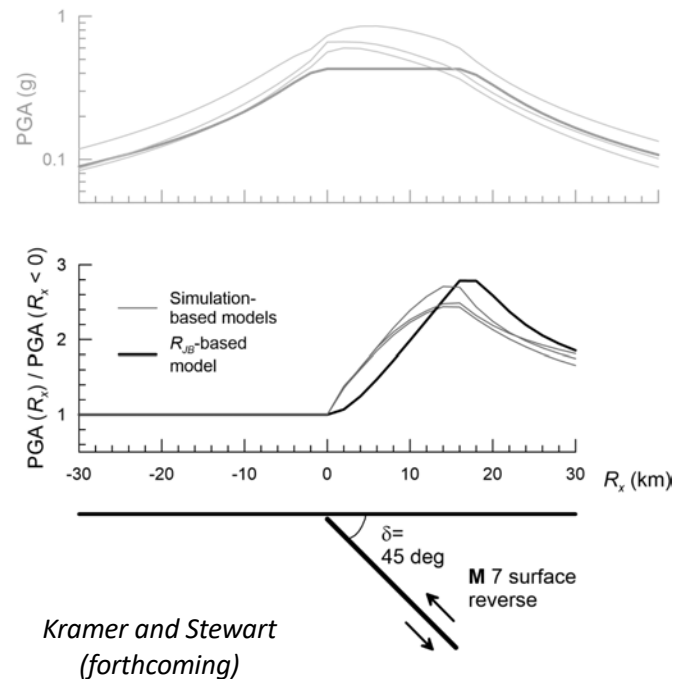
Example application: Hanging wall effects

- Footwall attenuation (reference)
- Flat / lower attenuation on hanging wall
- Hanging wall amplification

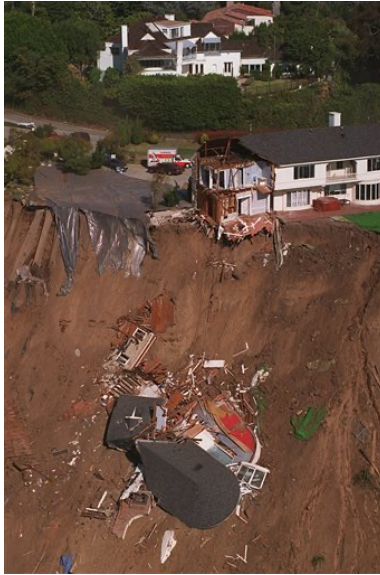
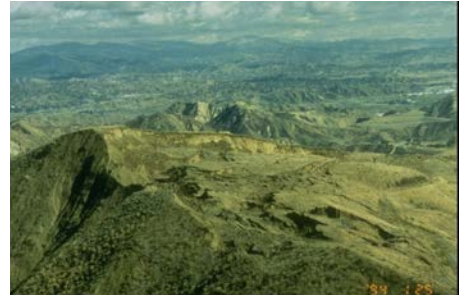
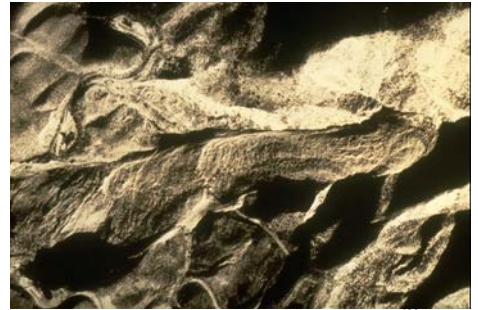
Types of Ground Failure from Northridge Earthquake

Landslides

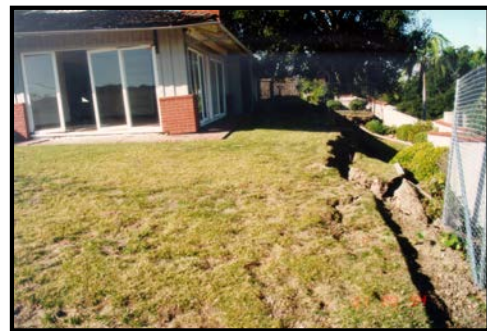
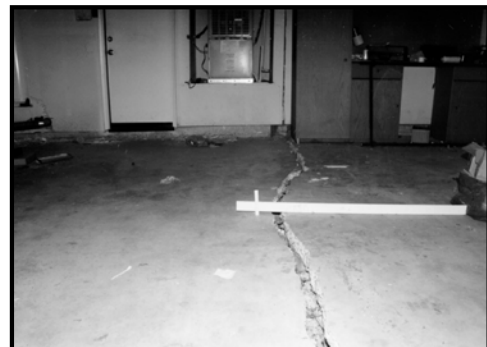
Seismic compression

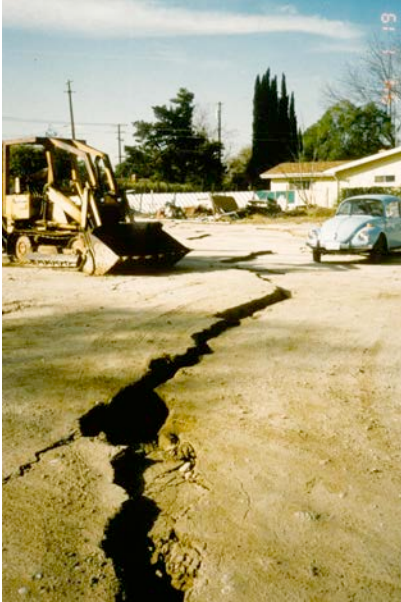
Malden Street; *J. Tinsley*

Strength loss in loose, saturated soils during cyclic loading

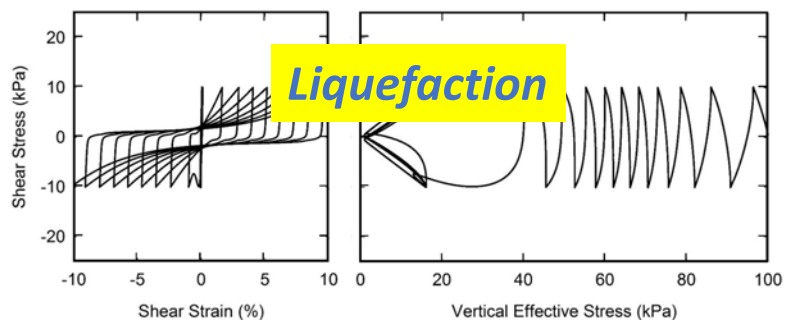
- “pinched” stress-strain loops
- Near-zero effective stress
- Severe strength loss

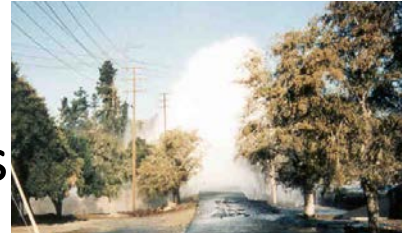
Water and Sewer Systems (Most impacts to LA City Systems)

- Water Systems
 - Thousands of pipe repairs
 - Damage to Aqueduct and transmission lines
 - Damage to tanks, reservoirs, & treatment plants
 - Service impacts to ~1,000,000 people
 - Boil Water notices issued
 - Loss of water to fight fires
 - All services restored within weeks
 - System repairs completed in years
- Sewer Systems
 - Pipe and treatment plant damages
 - Service outages not substantial

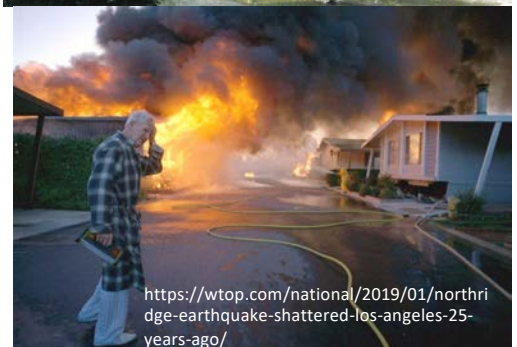
Natural Gas (So. California Gas Company)

- Pipe damages
 - 35 transmission (old lines)
 - 3 fires
 - 154 distribution (steel)
- All newer pipes performed well
- 151,000 customers out of service (88% shut off own service)
- 51 natural gas related fires (private property)
- 172 mobile homes destroyed by fire (lack of seismic bracing)
- 82% of customers restored in 2-3 weeks

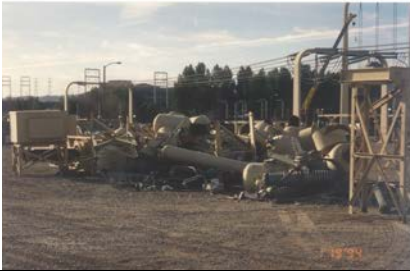
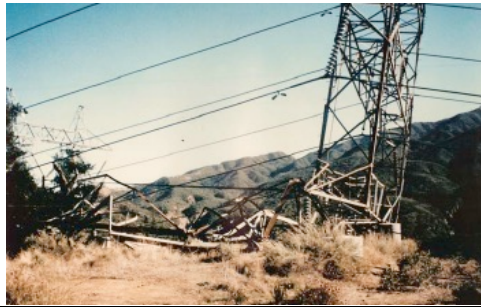
Electric Power (LADWP and SCE most impacted)

- Damage to Transmission Towers, Converter & Receiving Stations.
- **Power lost to entire City of LA** for 1st time ever
- LA restored 93% customers in 1.5 days, completed within 2 days
- SCE had 825,000 customer outages, restored in 20 hours
- Power Grid impacts resulted in **outages across Western USA and Canada**

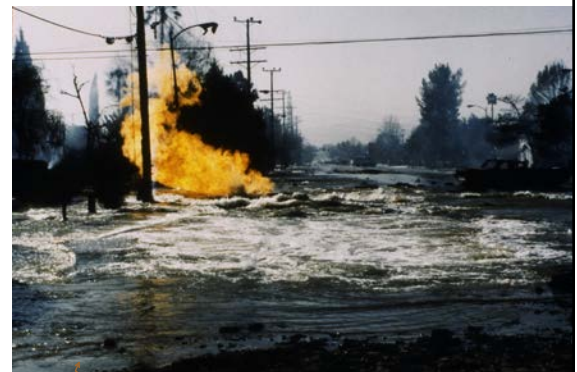
Interdependencies Example – Balboa Blvd.

- Ground failure ~20" displacement, damaged road & water and natural gas pipelines
 - New natural gas pipelines were not damaged
- Street flooded
- Spark from truck engine ignited gas leaking from an old pipe
- Burned homes and electrical lines
- Disrupted communication cables (explosion + flood)
- Balboa Blvd. is designated as an emergency evacuation route
- Post earthquake repairs were difficult to coordinate between all collocated utilities – causing repair delays

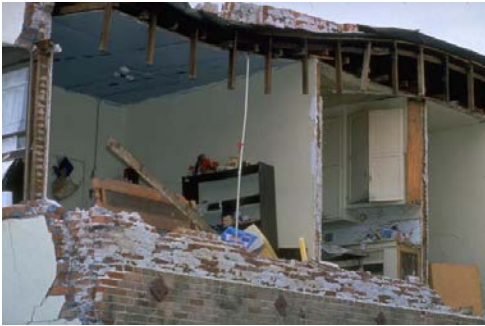
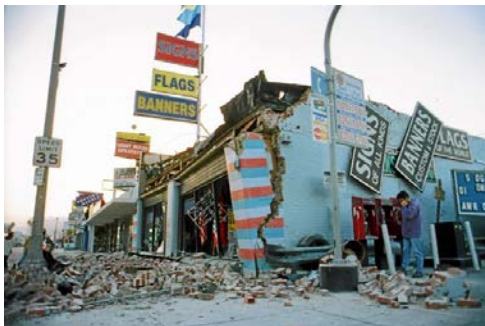
Unreinforced Masonry Buildings

DIVISION 88 - Earthquake Hazard Reduction in Existing Buildings (URM)
Ordinance 159068 Eff. 7/29/84 Oper. 1/29/1985 Mandatory

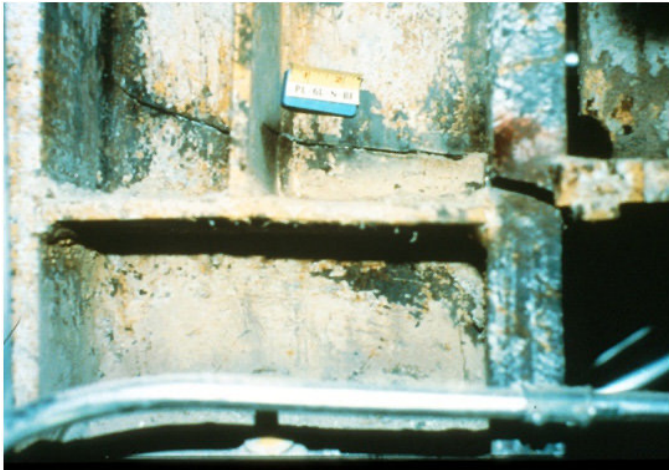
Steel Moment Frame Buildings

“best” LFRS showed surprising damage

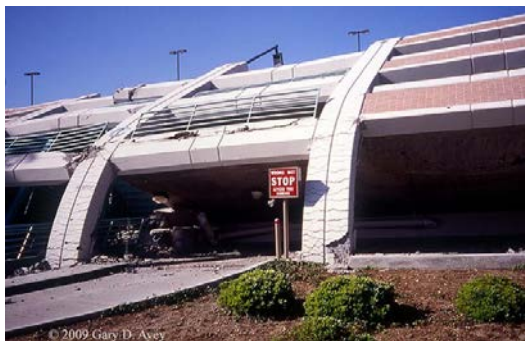
Parking Structures

- Deformation compatibility
- Pre-cast concrete connections

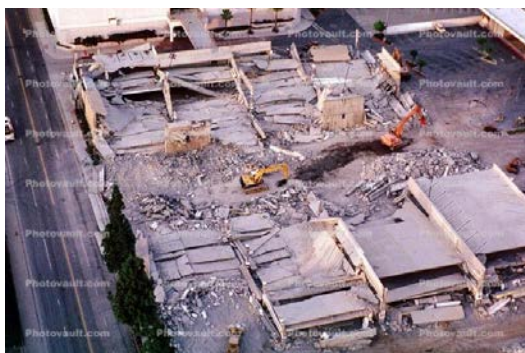
Code changes:

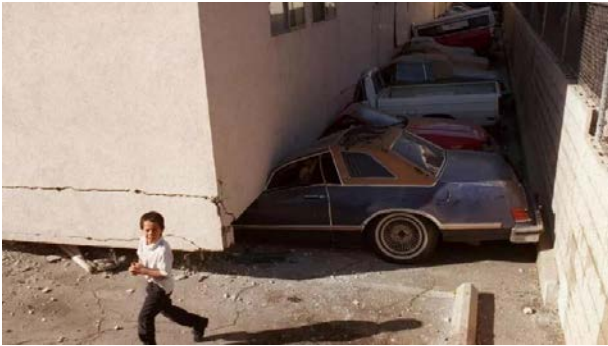
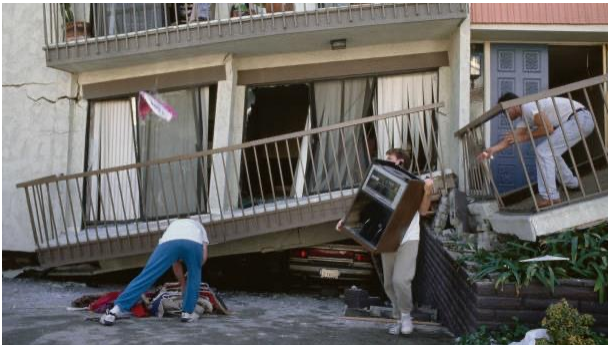
Soft-Story Buildings

DIVISION 92 - Voluntary Earthquake Hazard Reduction in Existing Wood-Frame Residential Buildings with Weak Cripple Walls and Unbolted Sill Plates
Ordinance 171259 Eff. 8/30/96

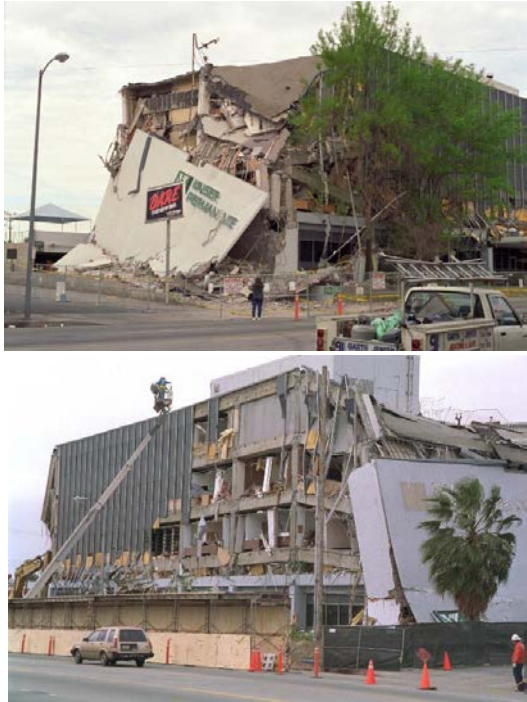
Non-ductile Concrete Buildings

LA Ordinances:
DIVISION 95 -
Mandatory Earthquake
Hazard Reduction in
Existing Non-Ductile
Concrete Buildings
 Amended in Entirety by
 Ordinance 183893 Eff.
 11/22/15
